FedEx Package Test/Evaluation Report # : 18779**Service Information**

Commodity Code : 25	UN No :	Model Number: EX	Pcs. Per Pkg: 1
Values : \$10,000.0	Product Description: Razor - Lab instrument		
Package Density(lb/in3): 0.003

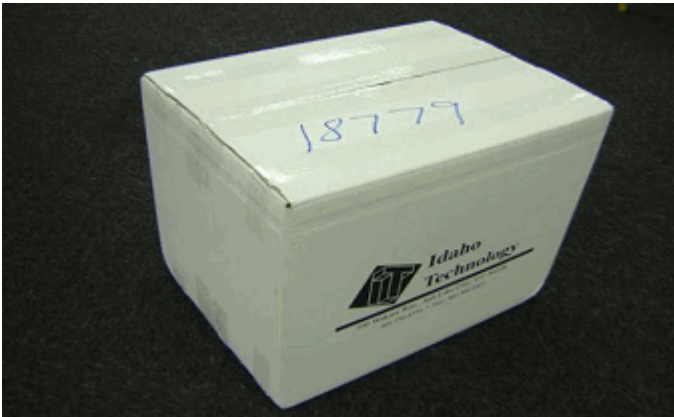
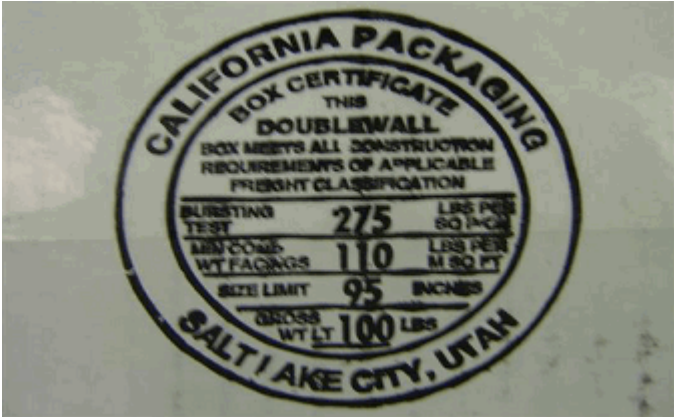
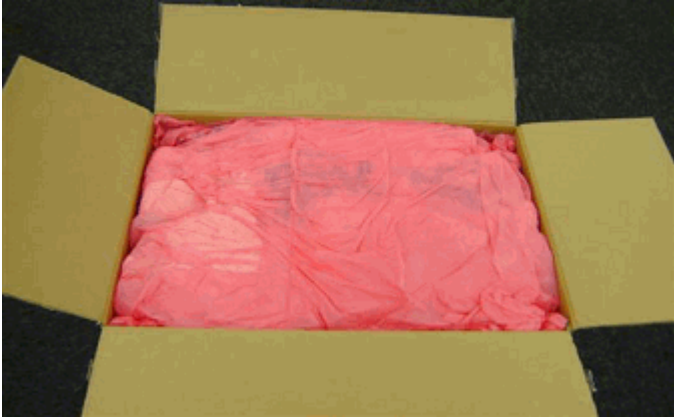
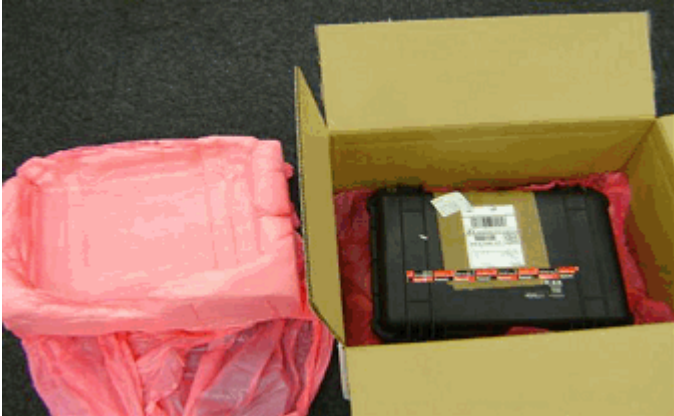
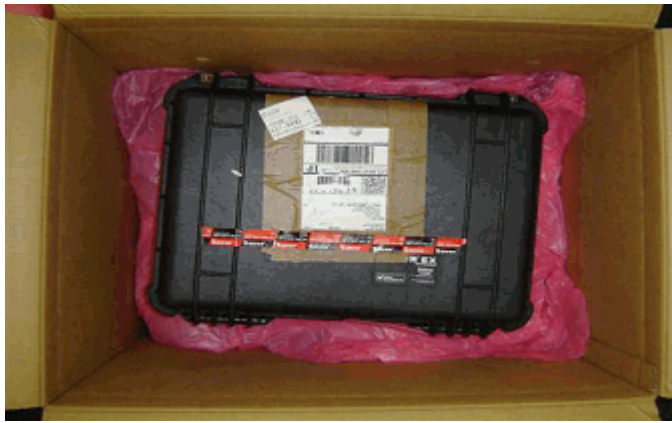
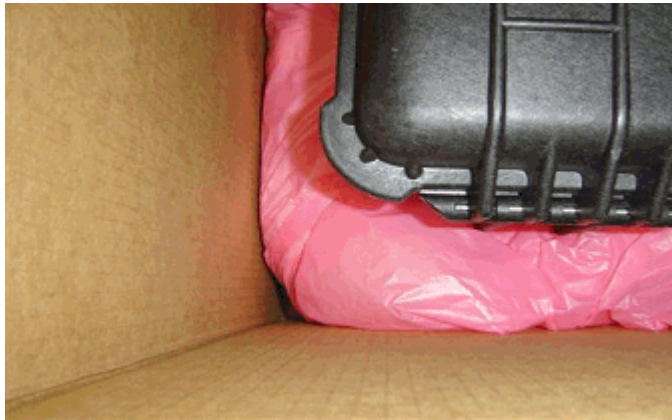
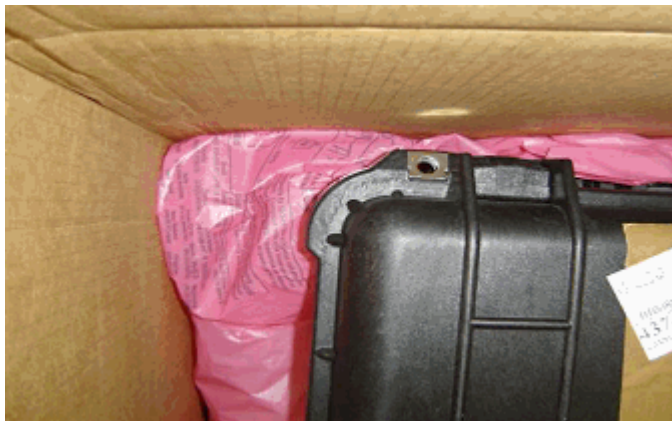
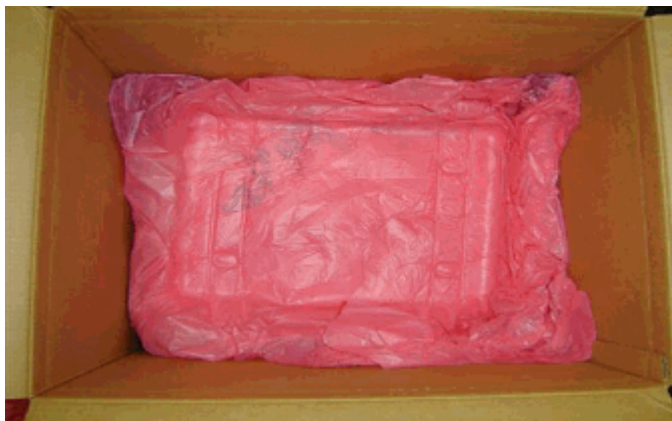
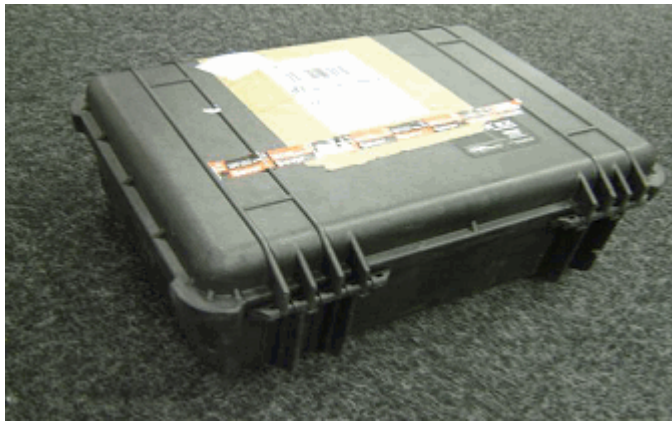
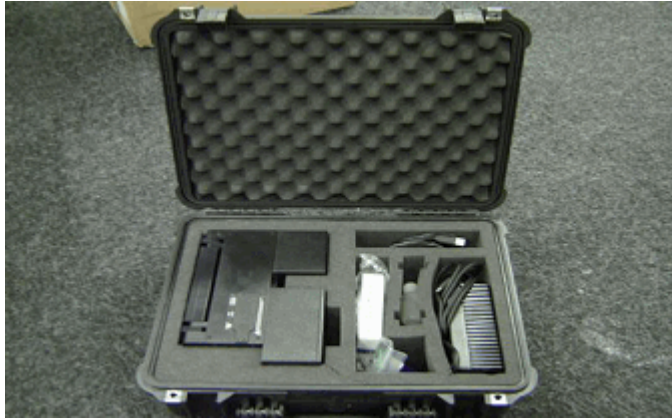
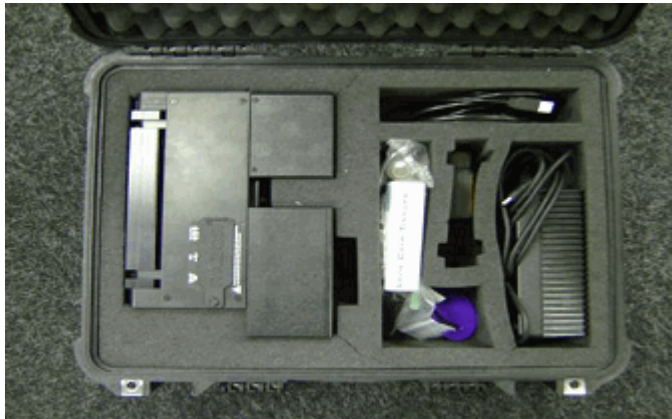
Photos/ Drawings (if Applicable)

Other Inner Info: Product inside pelican case lined with polyurethane foam. Instapak foam on top and bottom. (See pictures)

Peak compression force was 1017.8 lbs with a deflection of 0.72", thereby meeting 74.28% of the target (1370.250 lbs). This may be attributed to the softness of the Instapak cushioning. Should not pose a risk.
